**DEPARTMENT OF TRANSPORTATION**

Contract #: 04-0120F4Cty: SF/ALA Rte: 80 PM: 13.2/13.9File #: 69.28**WELDING INSPECTION REPORT****Resident Engineer:**Siegenthaler, Peter**Address:** 333 Burma Road**City:** Oakland, CA 94607**Report No:** WIR-018936**Date Inspected:** 01-Dec-2010**Project Name:** SAS Superstructure**OSM Arrival Time:** 700**Prime Contractor:** American Bridge/Fluor Enterprises, a JV**OSM Departure Time:** 1900**Contractor:** Zhenhua Port Machinery Company, Ltd (ZPMC), Changxing Island **Location:** Shanghai, China**CWI Name:** Mr. Xu Le Feng**CWI Present:** Yes No**Inspected CWI report:** Yes No N/A**Rod Oven in Use:** Yes No N/A**Electrode to specification:** Yes No N/A**Weld Procedures Followed:** Yes No N/A**Qualified Welders:** Yes No N/A**Verified Joint Fit-up:** Yes No N/A**Approved Drawings:** Yes No N/A**Approved WPS:** Yes No N/A**Delayed / Cancelled:** Yes No N/A**Bridge No:** 34-0006**Component:** Tower / OBG**Summary of Items Observed:**

## WELDING INSPECTION REPORT

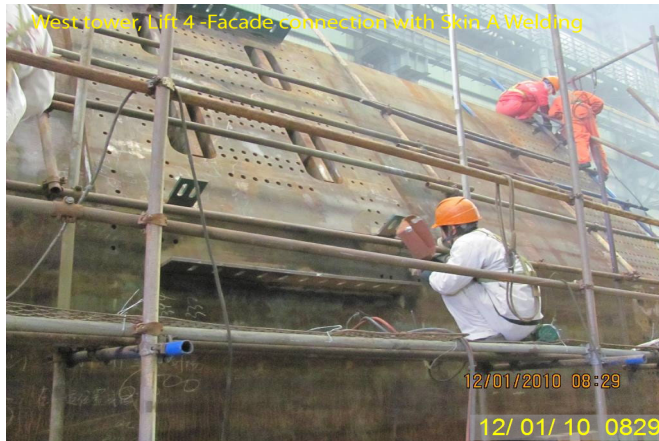
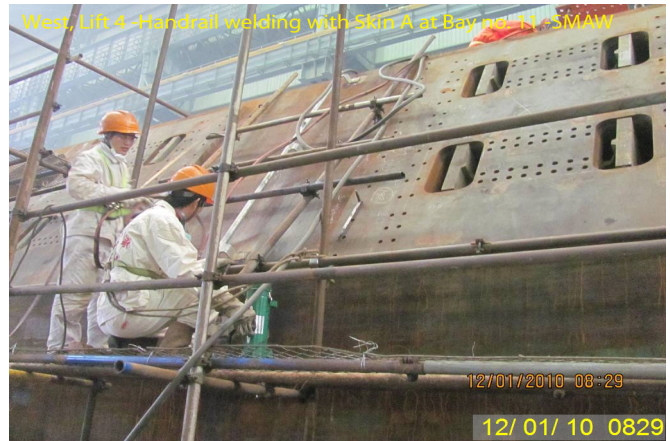
For further information see below pictures:-

Unless otherwise noted, all work observed on this date appeared to be in general compliance with the applicable contract documents.
